**SUGARWORLD WATER PARK
WATERSLIDES CONDITION ASSESSMENT**

REPORT NO. 10485_1

April 2010

pdr engineers
ABN 88 126 211 461

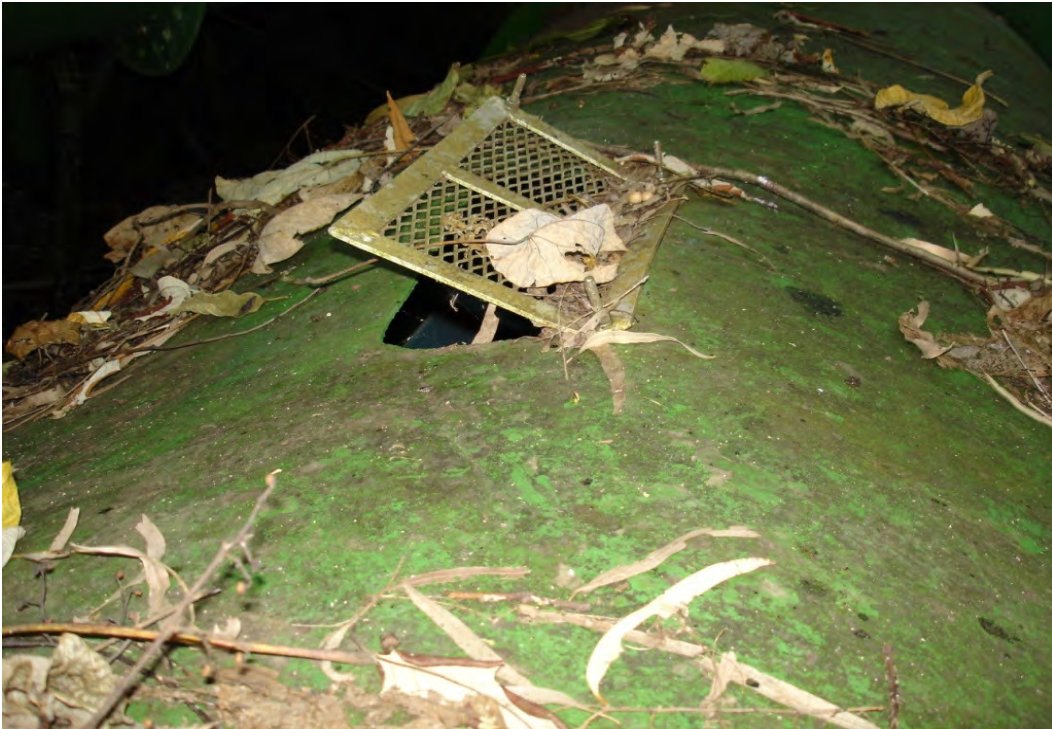
3. Open air vents to top of tubing

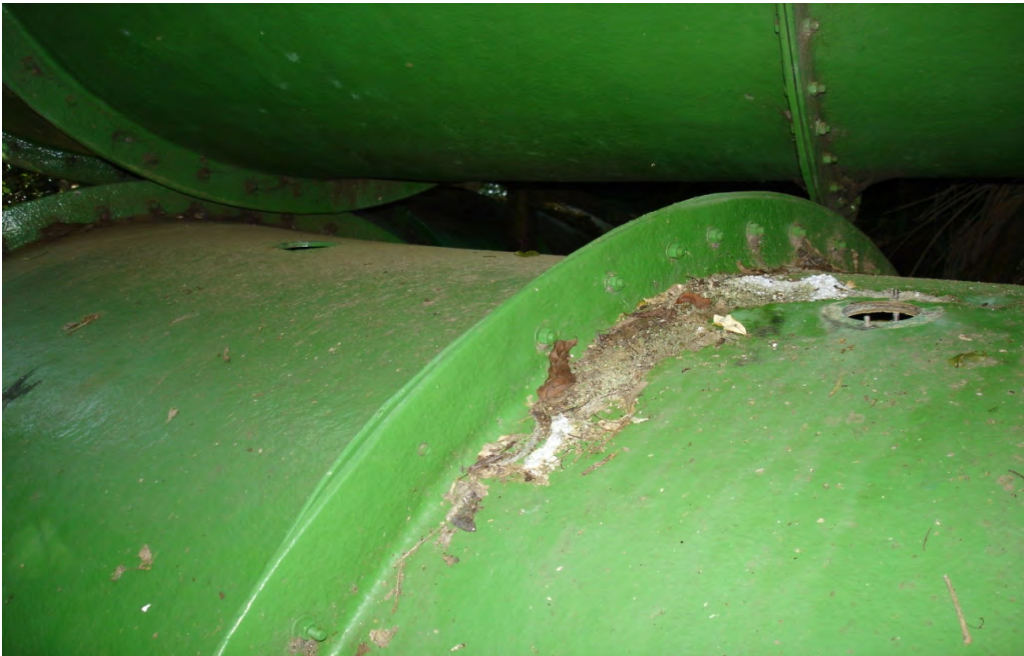
4. Holes to top of tubing at missing lights

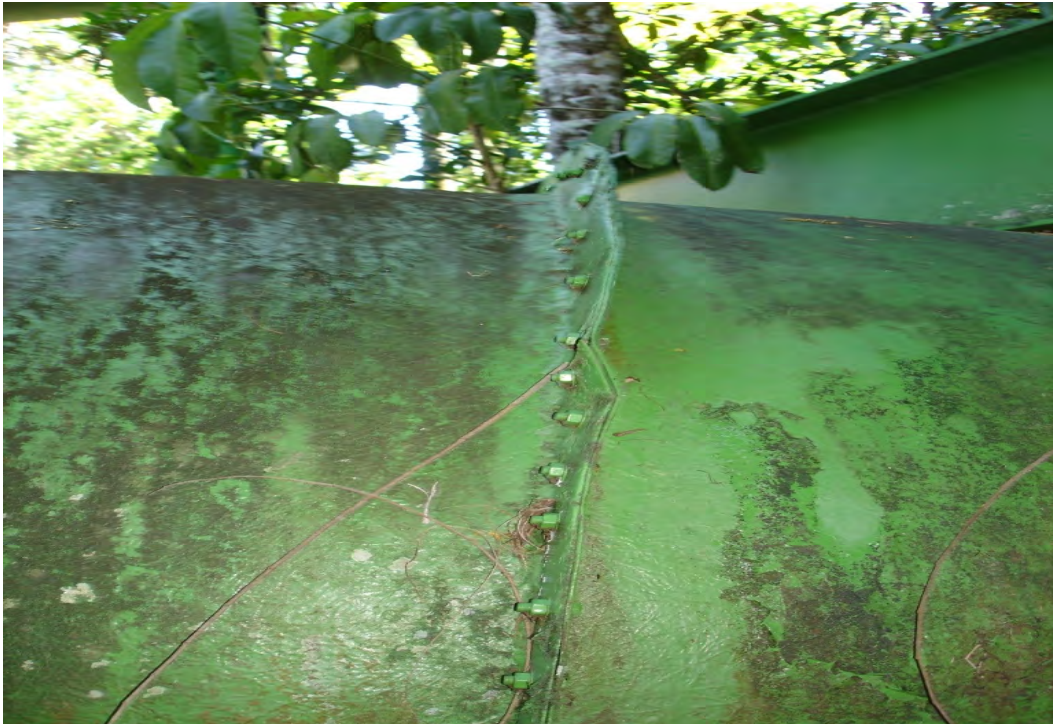
- Noted some nuts/bolts missing to vertical flange joints (Photo 11).
- The tubing flange joints have cracked, delaminated or buckled in a few locations of the slides.
- Visible buckled horizontal tubing flanges due load concentration between the steel support points and the tubing flanges.

5. Vertical tubing flange joints buckling

- Re-seal of all flanged joints that show leakage or gaps
- Remove and replace joint sealant that is deteriorated and apply flexible water tight joint sealant
- Install missing bolts and nuts to flange joints
- Repair all tubing flange joints that shows cracking, delaminating or buckling. Steel clamp plates may need to be installed to provide additional support.

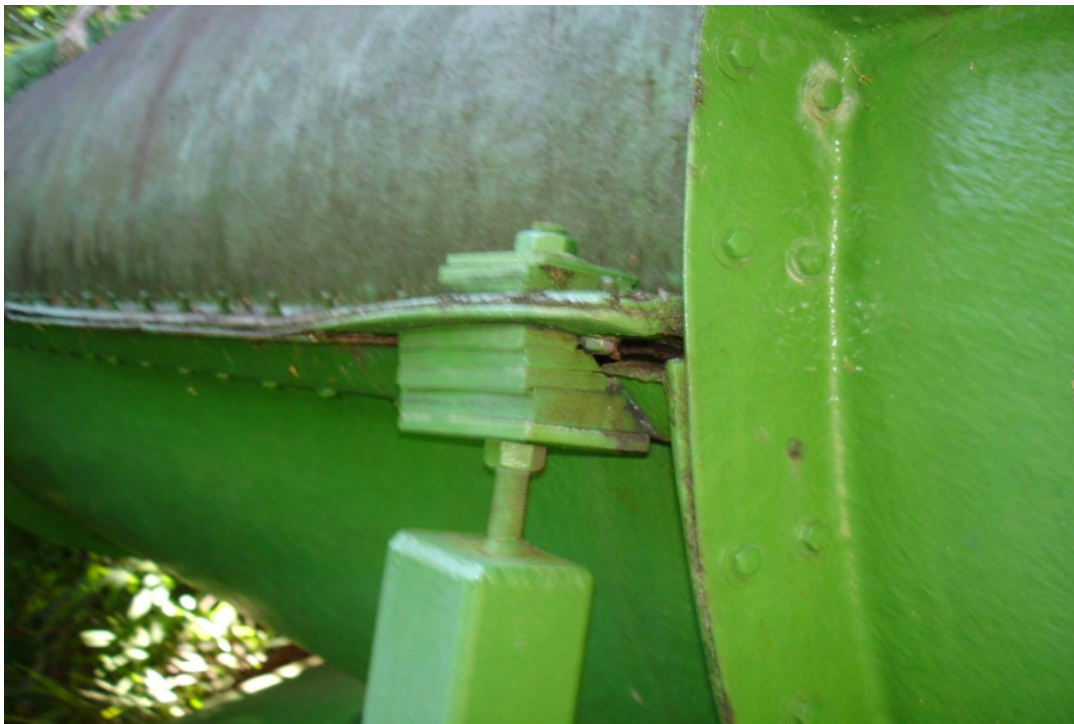
6. Flange joints cracking and buckling at support locations

- Dismantle and/or repair all the severely corroded steel work
- Re-fabricate the repaired steelwork
- Repaint all the repaired steelwork with a high durability paint system
- Provide an alternative saddled support system for the tubing to eliminate buckling of horizontal flange joints at support points.

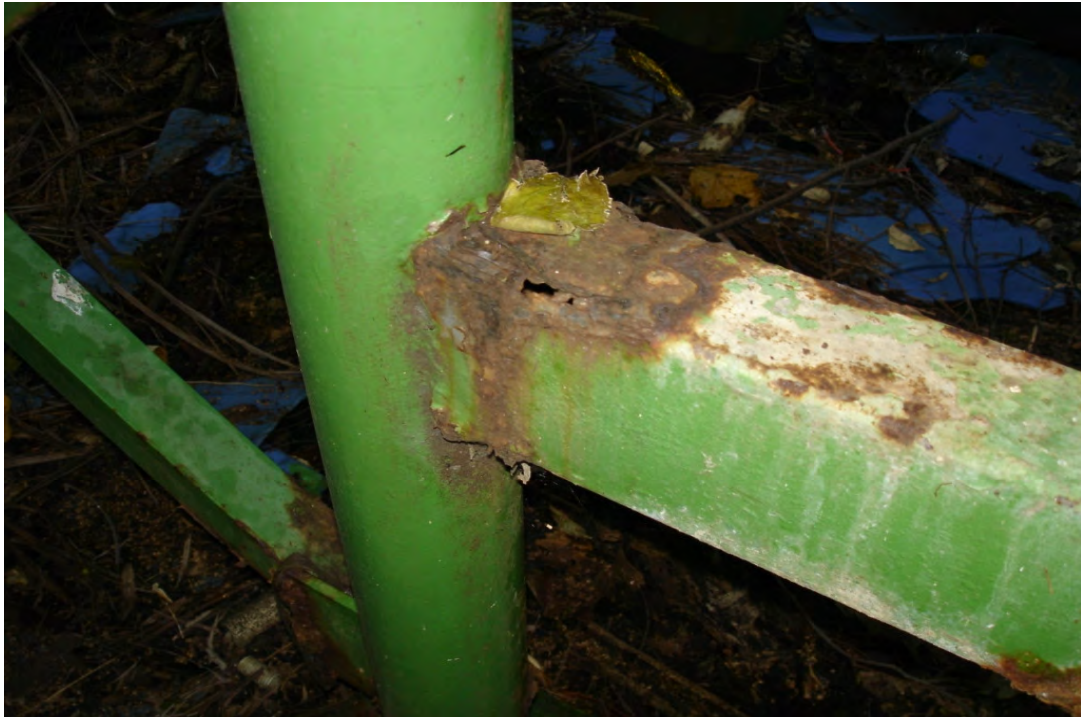
- Steelwork and connections show severe corrosion in some areas due to chlorinated water leakage from the tube flange joints. There are a number of locations where steelwork and connections are in a dilapidated state. The corrosion is typical of painted steelwork exposed to chlorinated water.
- One location of the steel frame shows a hole through the steelwork due to severely corroded steel joint.
- The concrete footings supporting the steelwork do not show any signs of movement or settlement.

7. Severely rusted steelwork for The Cyclone waterslide

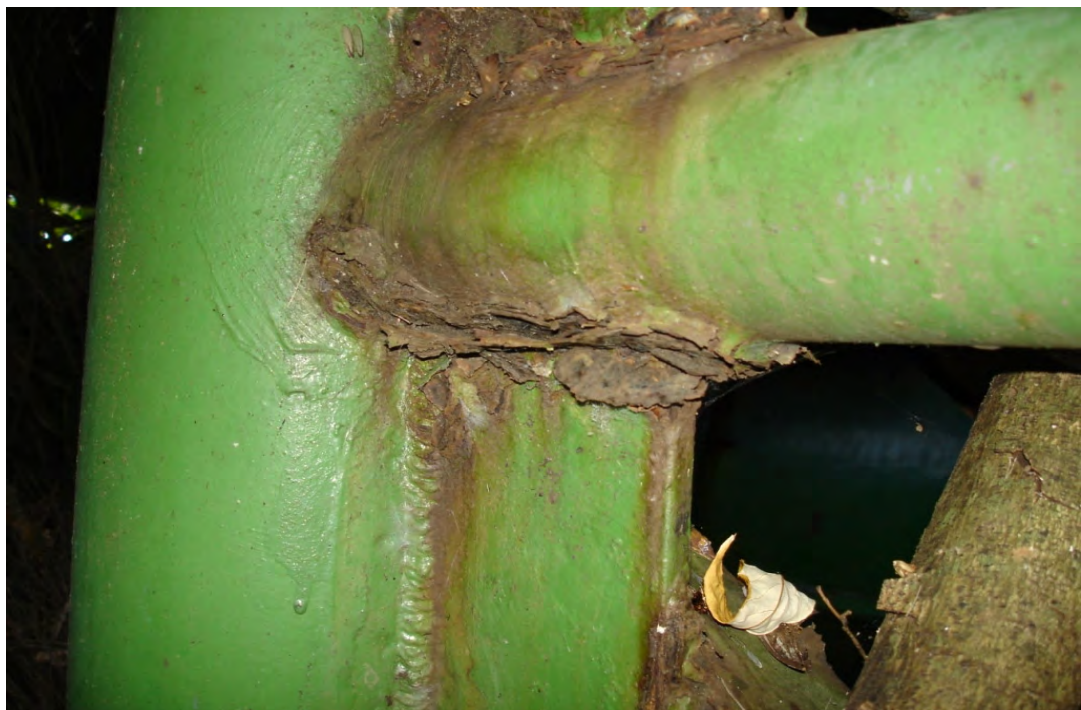
8. Corroded steel tubes for The Cyclone waterslide

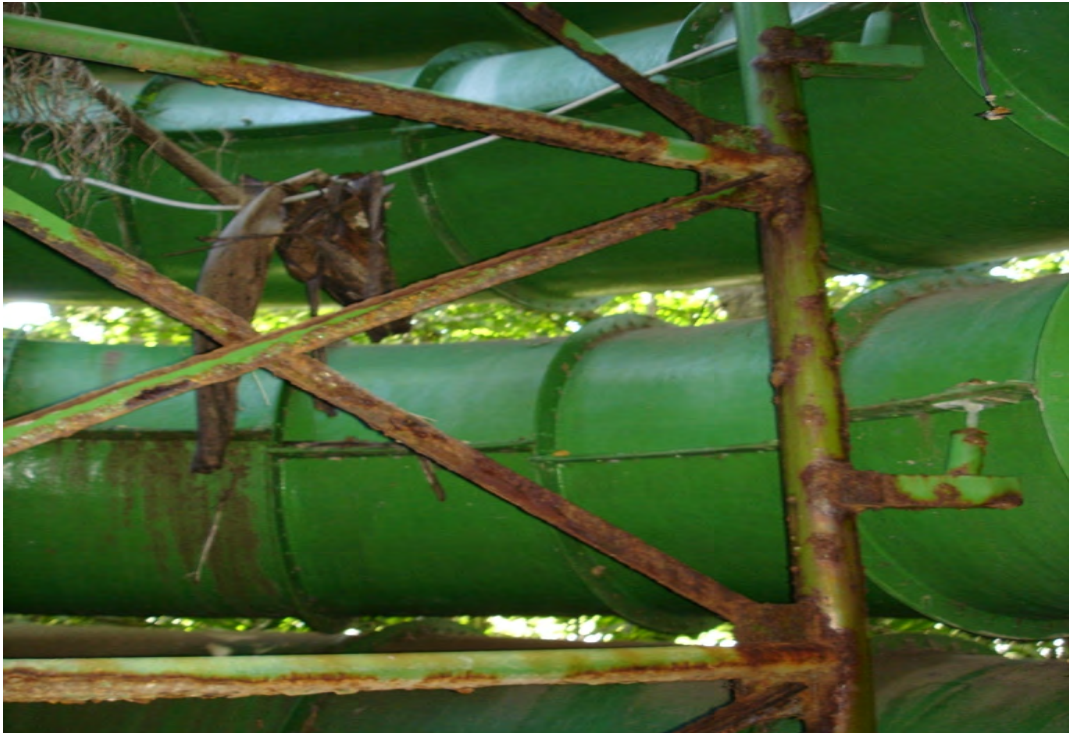
9. Corroded steel frame supporting tubes for The Cyclone waterslide

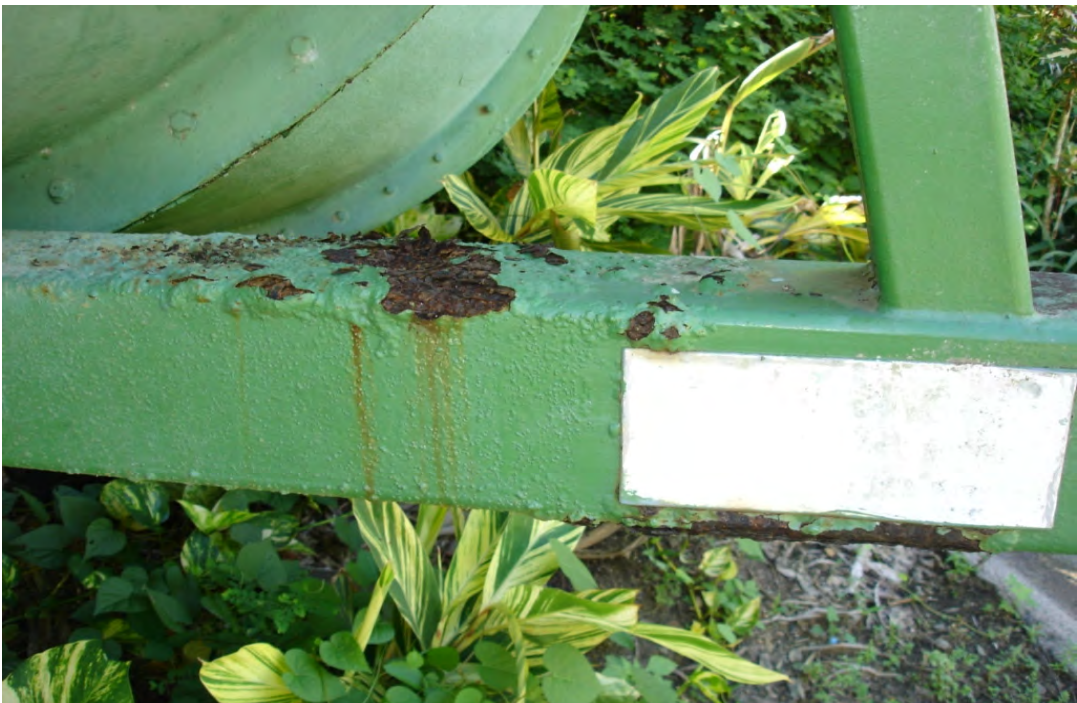
10. Steelwork rusting to Flying Fox waterslides

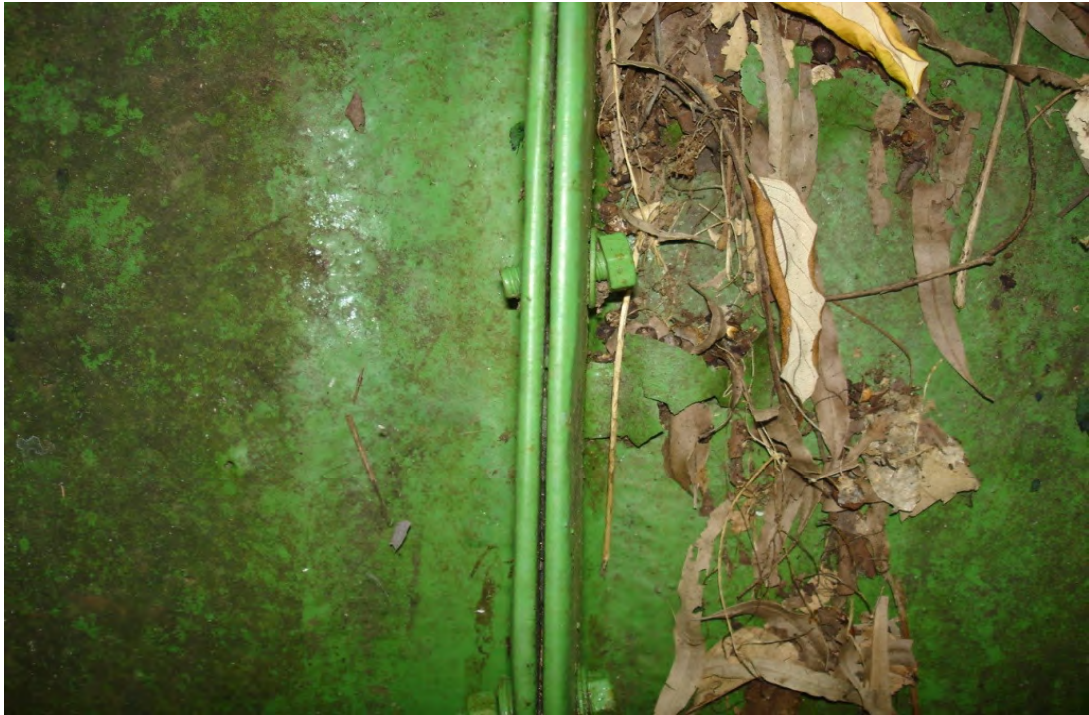
11. Missing bolt nut

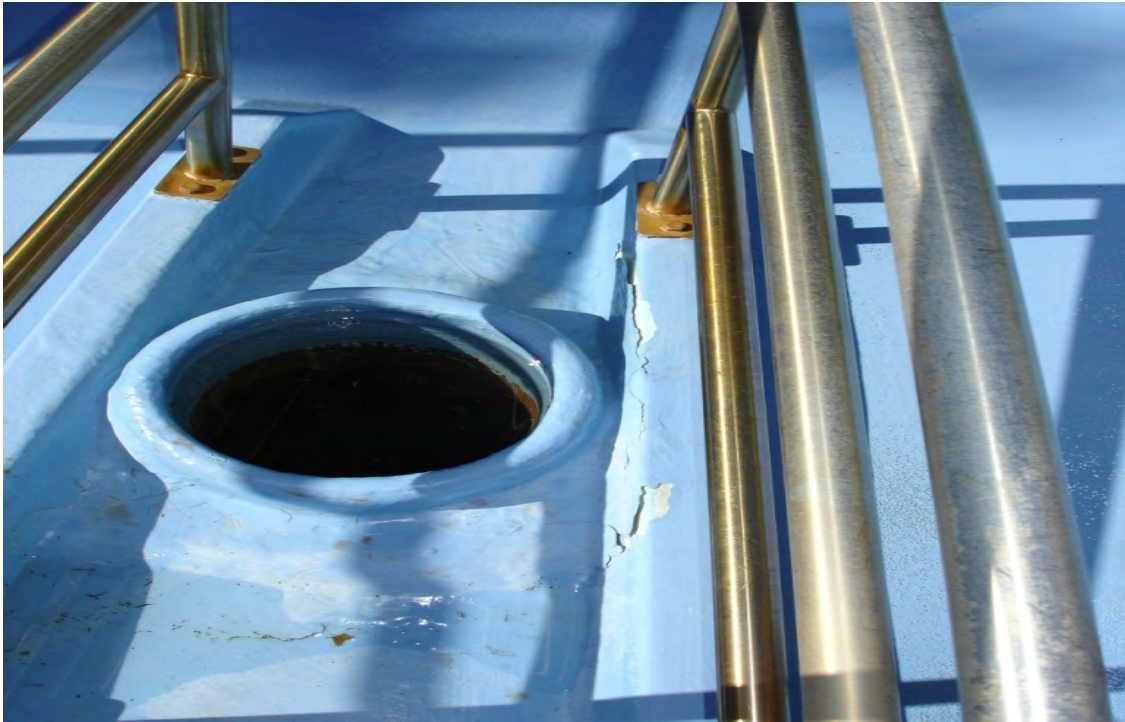
13. Cosmetic delamination of paint finishes near waterslides entry

- All the current repairs to the interior of the fibreglass tubing to be checked for their integrity.
- Re-condition all the tubing interior of the waterslides following the above, which will involve re-fibre glassing plus gel coat.
- Re-painting of all the exterior of the waterslides tubing

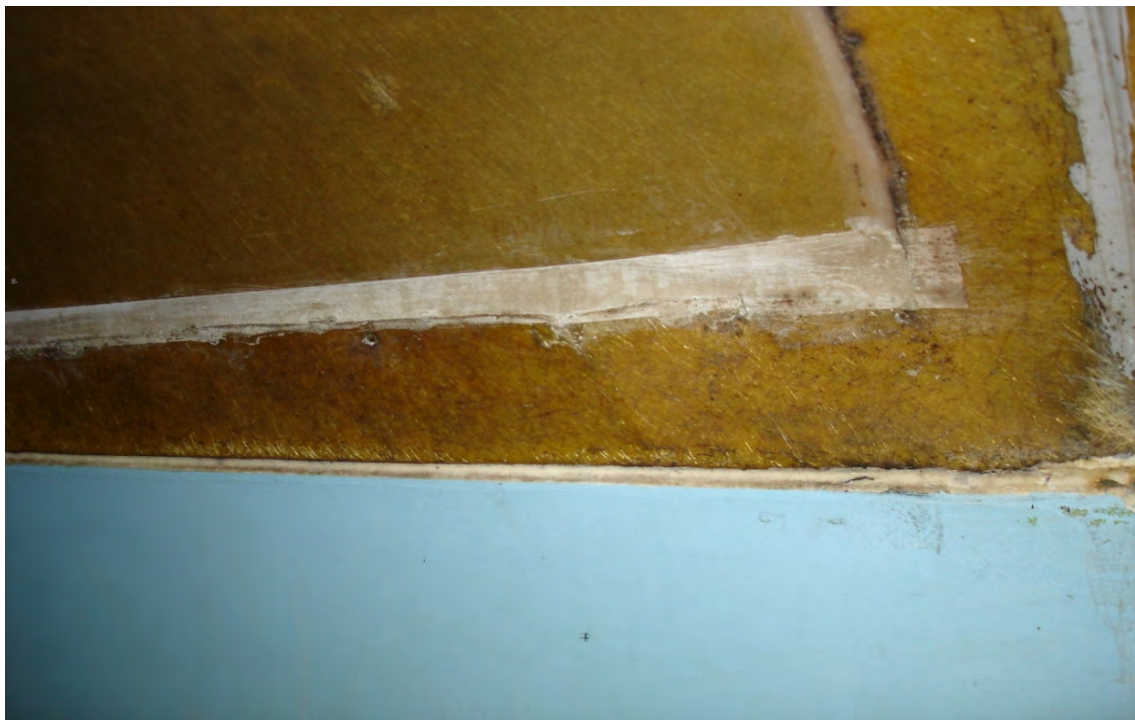
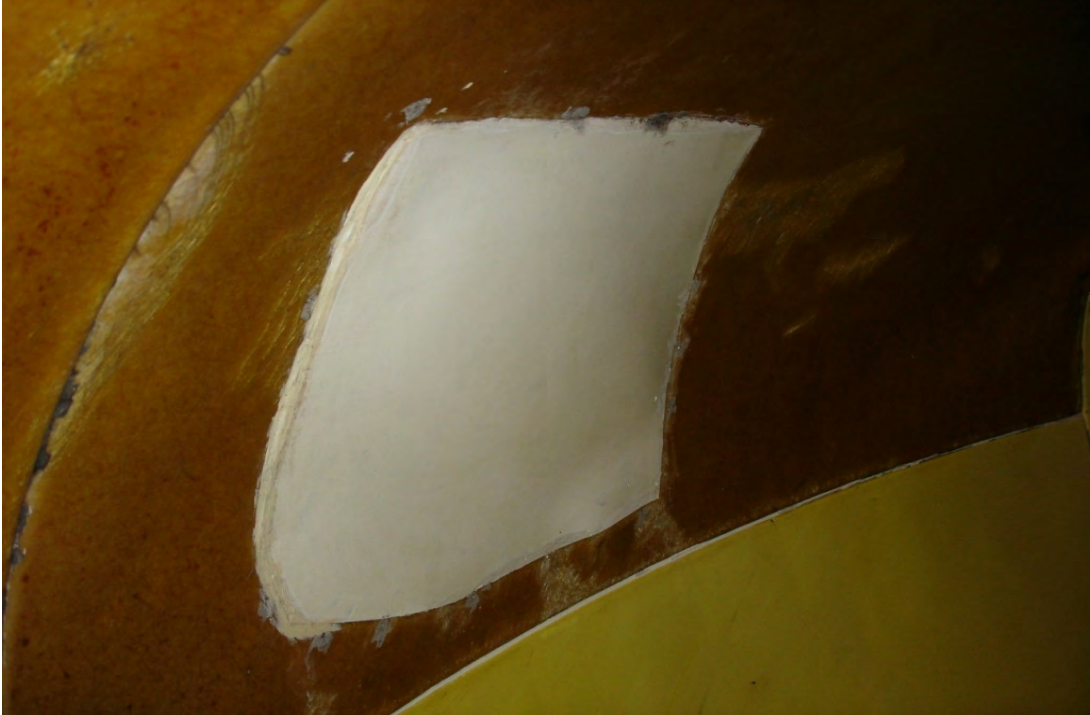
14. Patching to tubing walls

15. Patching to tubing walls

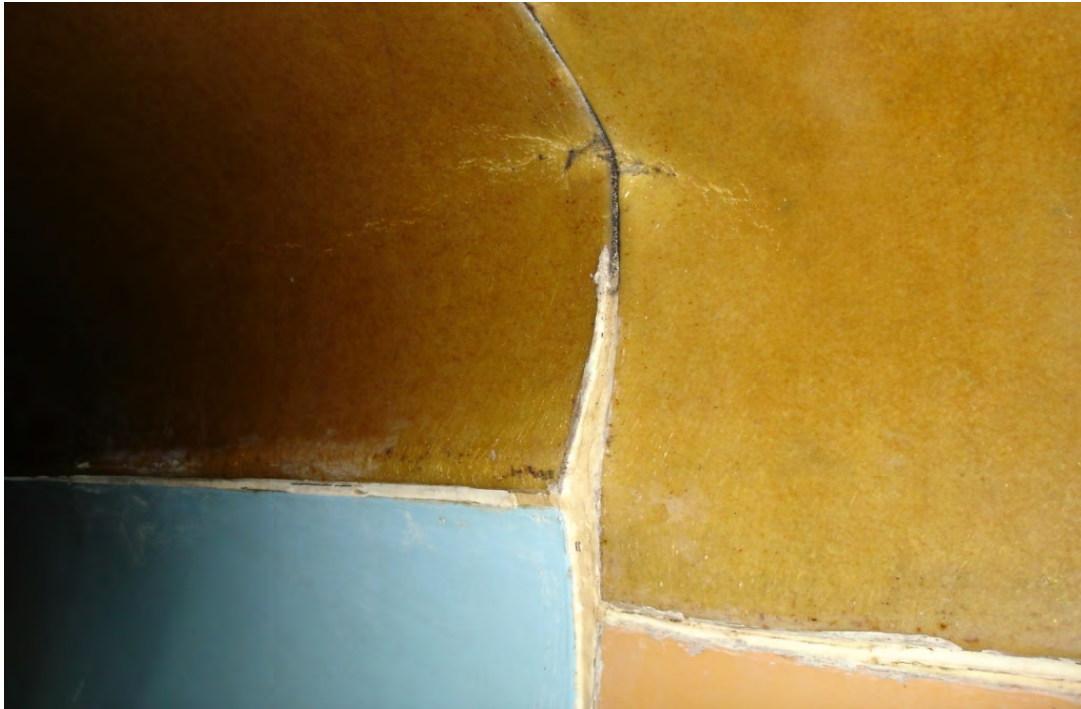
16. Inward bowing of the tubing due to overgrown tree

- Replace entire tubing for sections that cannot be adequately repaired. Note this action might require the waterslide in repair to be closed during the tube moulding and replacement.
- Undertake tree logging to branches lying on sections of the waterslide and on the ground adjacent to the waterslides
