Report on Management of Drowning Risks

# Babinda Boulders

COPY  
Report on Management of Drowning Risks | Babinda Boulders (2022)

ASSESSOR  
Oliver Fearman | Consulting  
email: ofearman@hotmail.com  
phone: +61 458 084 325

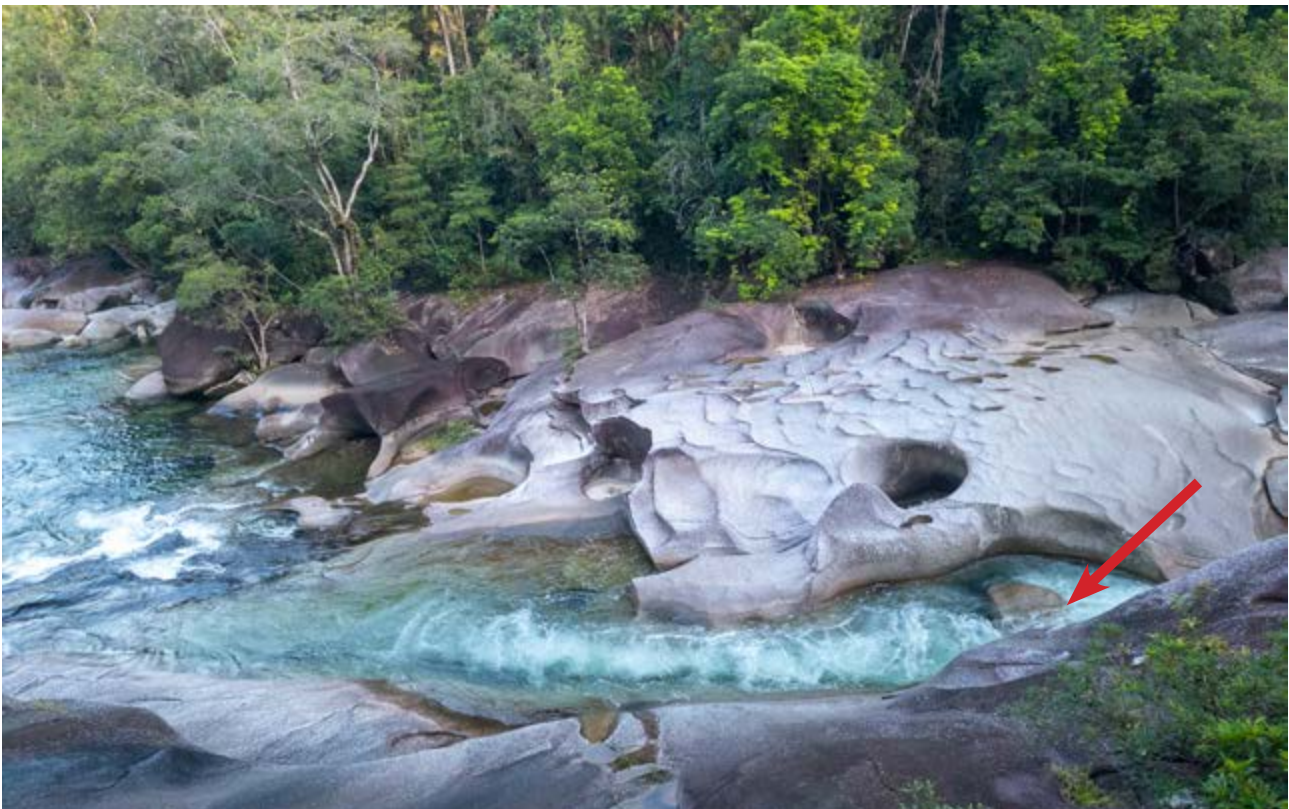
RED ARROW SHOWS CONVEYED LOCATION OF AERATION AND REDUCED BUOYANCY HAZARD.

There are sections of the site (D3 and E3 – Map 2) where the path of waterflow and rock formation leads to a significant increase in bubble formation in the water. This reduces the density of the water and causes floating items, such as logs and people to sink/fall to the bottom.

Emergency Response personnel conveyed that this hazard is known to occur in the location shown in the image above. Standard practice for QFES teams working near this hazard is being secured to fall prevention equipment to manage the extreme risk associated with entering the creek here.

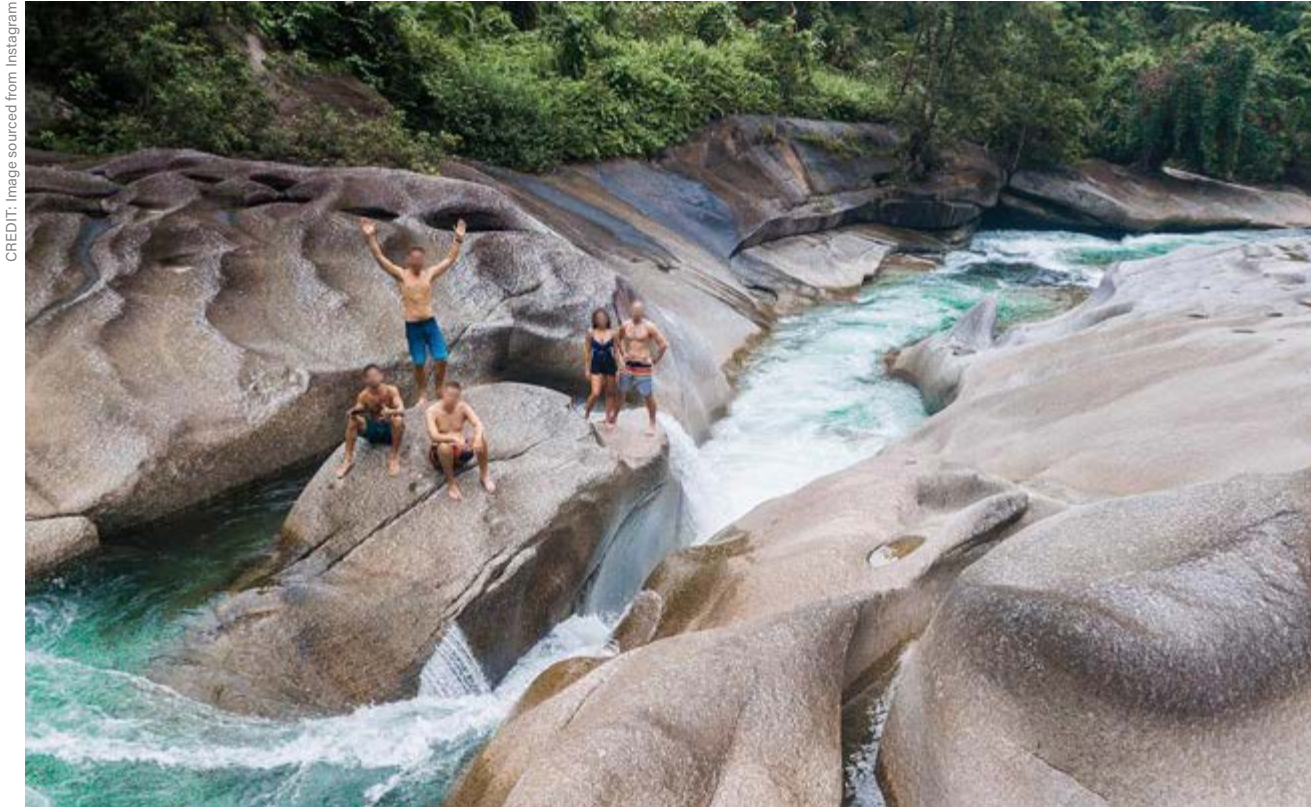
PERSONS IN IMMEDIATE PROXIMITY OF SECTION OF CREEK WHERE AERATION AND UNDERCUT HAZARDS HAVE CLAIMED NUMEROUS LIVES.

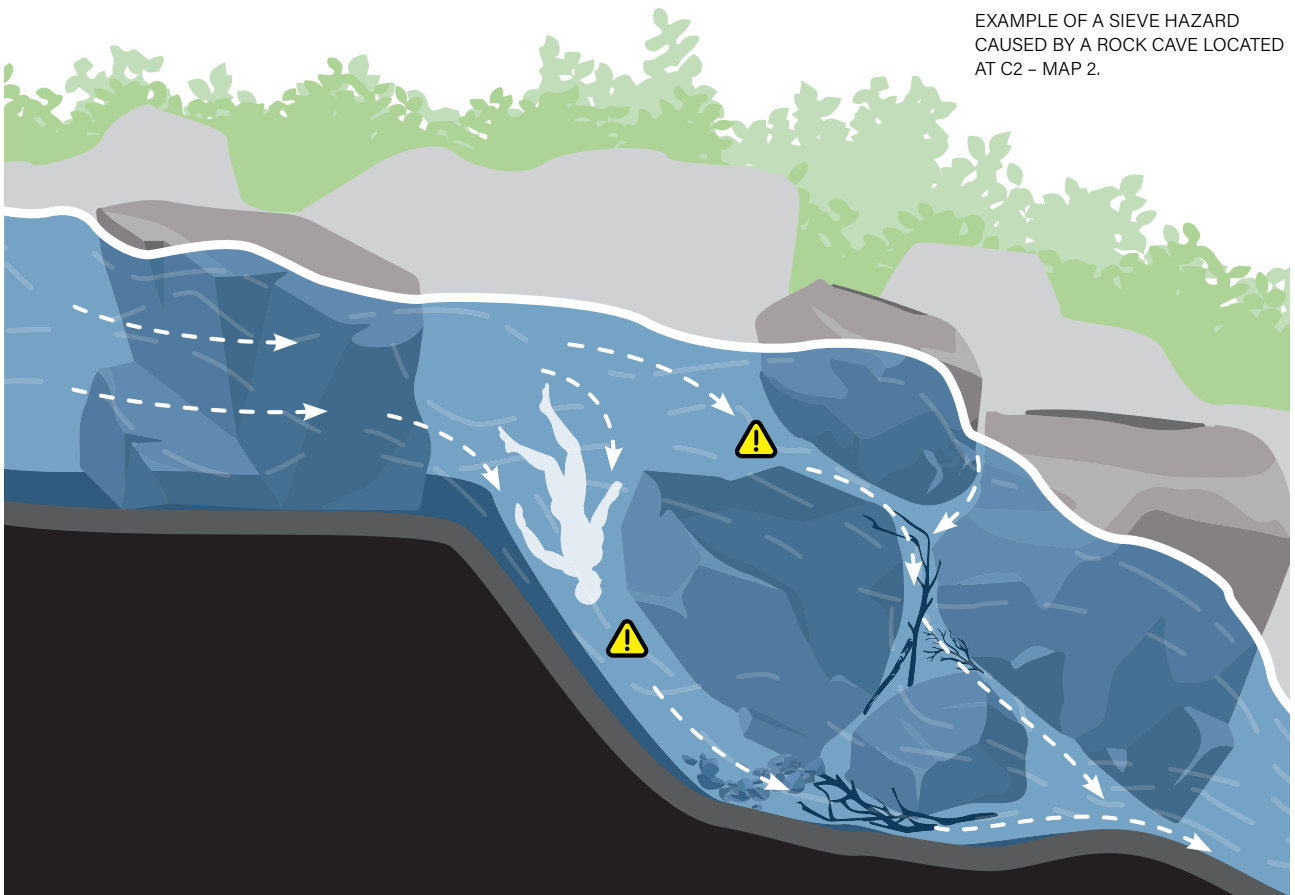
There are several locations on site (B2, C2, C3 and E3 – Map 2) where rock formation, caves and channels allow water to flow through but block larger items from passing through, such as logs and people. Gaps between rocks or caves in rocks force water through a smaller hole, creating the equivalent of a plug – a person can get sucked in, plug the gap and then not move out again because they are pinned by the weight of the water. These hazards are referred to as “sieves” or “siphons”. It was conveyed by numerous stakeholders that the areas above and below Devil’s Pool contain networks of such caves and crevices.

While the forces involved may vary depending on flow rates at the time, Emergency Response personnel conveyed that removing objects from such hazards can be physically impossible for a group of adults with retrieval equipment. A swimmer sucked into such a hazard will not be able to escape.

EXAMPLE OF A SIEVE HAZARD CAUSED BY A ROCK CAVE LOCATED AT C2 – MAP 2.

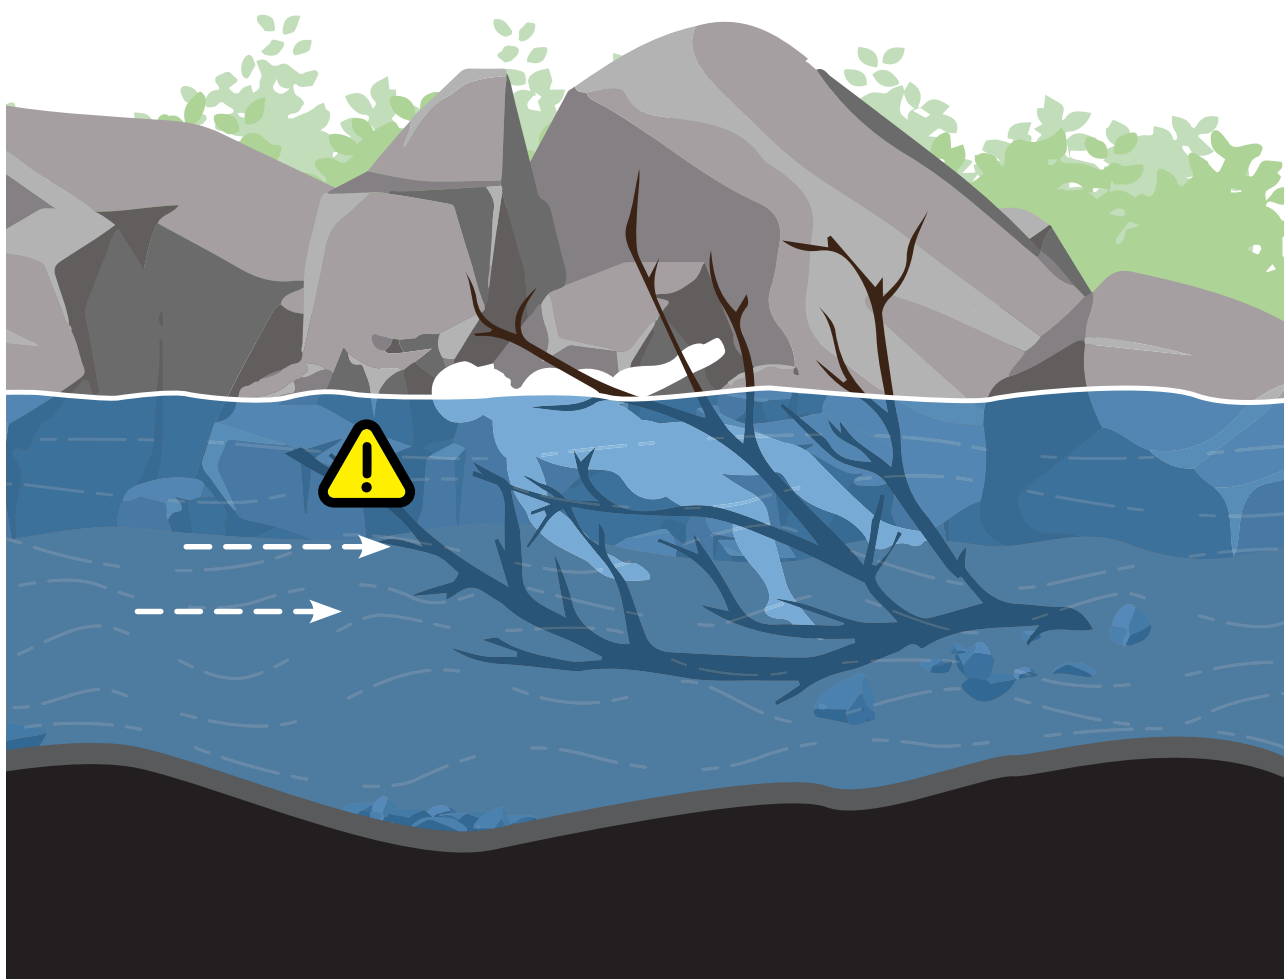
There are several locations on site (B2, C2, C3, D3 and E3 – Map 2) where obstructions such as logs and trees allow water to flow through but block larger items from passing through, such as logs and people. As with sieves, the forces involved may vary, and objects/persons stuck in such a hazard can be impossible to be physically removed.

STRAINERS: CURRENT PUSHES VICTIM/OBJECT INTO UNDERWATER SIEVE-LIKE OBSTACLES.

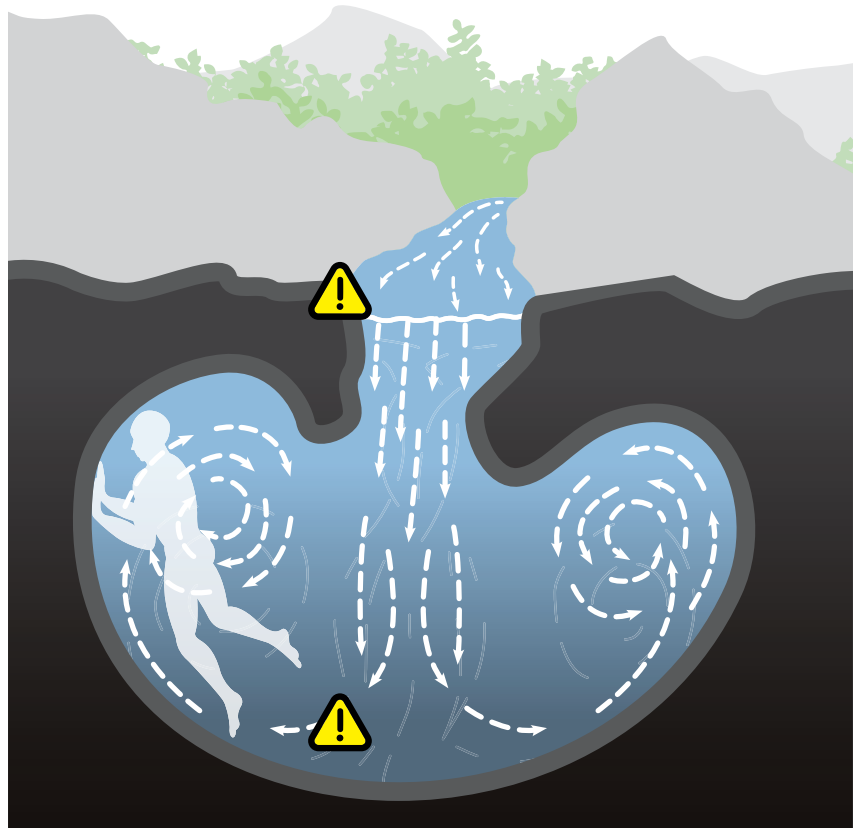
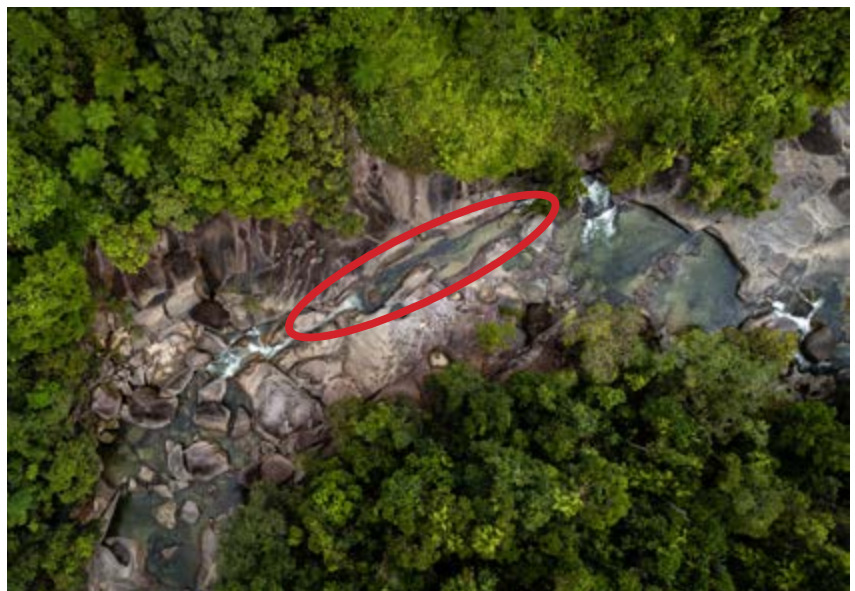
Particularly in the section of the creek referred to as “The Chute” (D3 and E3 – Map 2), the path of the water has created undercuts where water flows underneath the rock. Emergency Response personnel observed the chute channel using underwater cameras while attempting to locate and retrieve bodies. They reported that The Chute is approximately eight metres in depth and significantly wider in the deeper parts than near the surface. In such undercut hazards, once an object or person is pulled underwater, they are unable to get to the surface. Much like a person trapped under ice, they are trapped under a ceiling of rock, unable to find or move towards the open part of the channel.

It was conveyed that The Chute (see section depicted on photo beside) is approximately eight metres deep with significant undercut hazards where water flows through and under the rock forming the creek bed. All of the water passing through this creek must pass through the chute or the rock caves and undercuts below.

THE CHUTE SECTION (MARKED IN RED).

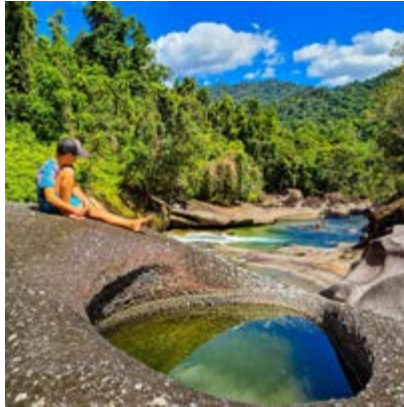
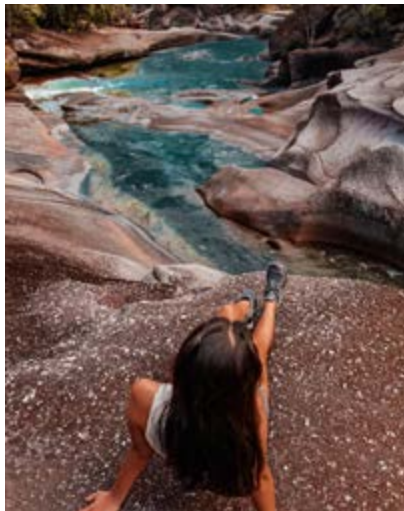
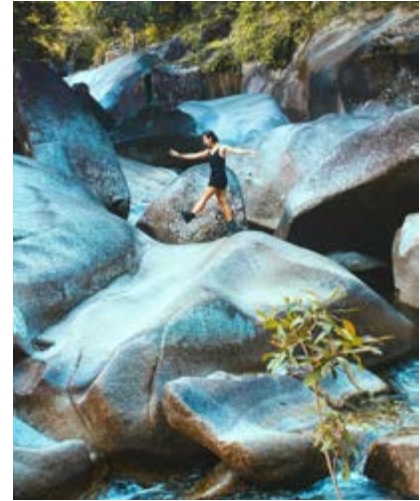
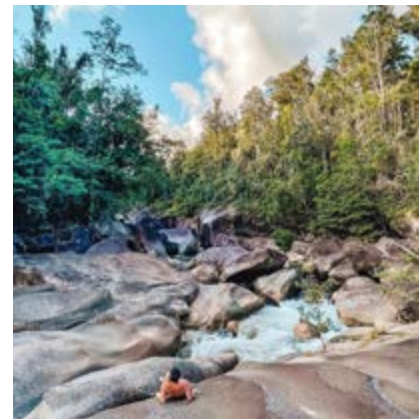
SOCIAL MEDIA IMAGES SHOWING PERSONS IN THE NO GO ZONES.

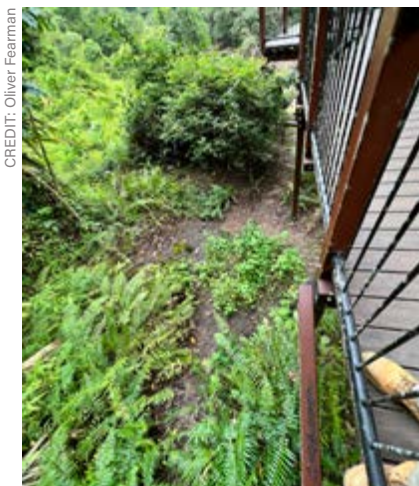
TRACKS WORN INTO VEGETATION AND TERRAIN IN THE NGZ, INDICATING REGULAR USE.

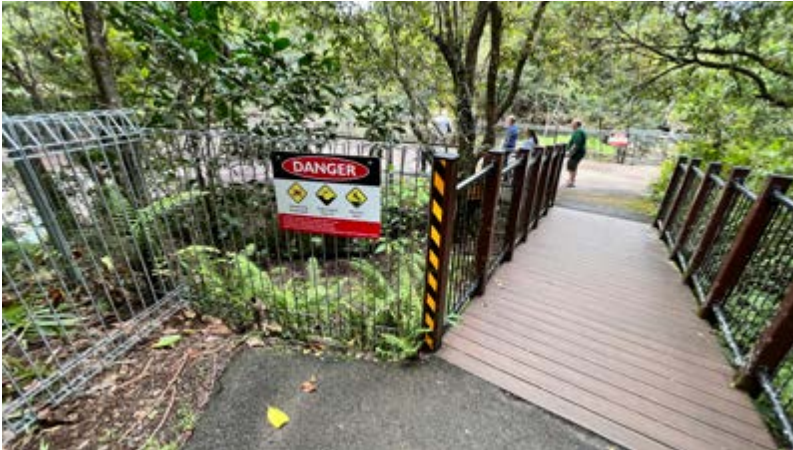
SIGNAGE LEADING INTO A PLATFORM FOR VIEWING THE NGZ. ICONS VERY SIMILAR TO THOSE OBSERVED AT THE ENTRY AND ALL ACCESS AREAS. KEY RISK MESSAGES IN RED AND WHITE ARE HARD TO READ ON PASSING.

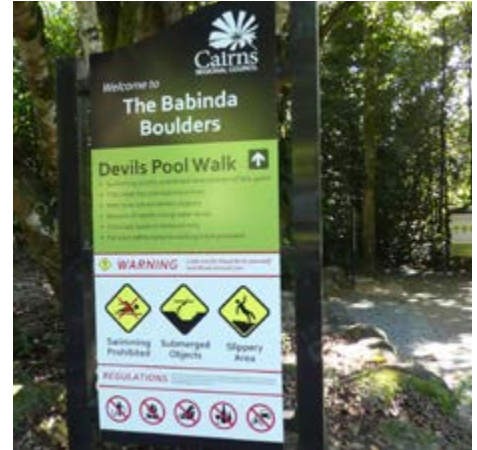
SIGNAGE OBSERVED WHEN ENTERING THE SITE. SIMILAR SIGNAGE IS LOCATED AT ALL ACCESS SWIMMING AREAS.

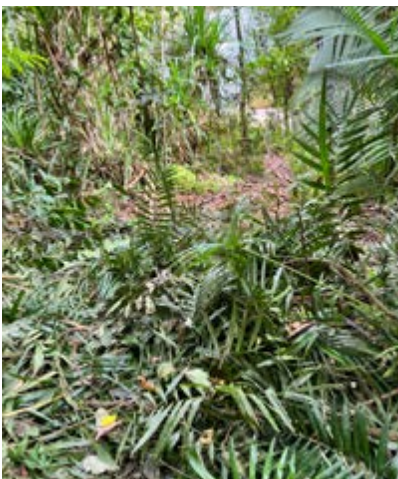
“WAIT A WHILE” CUTTINGS THAT HAD BEEN TRAMPLED BY PERSONS ENTERING THE NGZ. THIS WAS 24 HOURS AFTER PLACEMENT SUGGESTING SIGNIFICANT USE OF THIS UNOFFICIAL TRACK.
