Addressing coastal erosion at HOLLOWAYS BEACH

NOVEMBER 2019

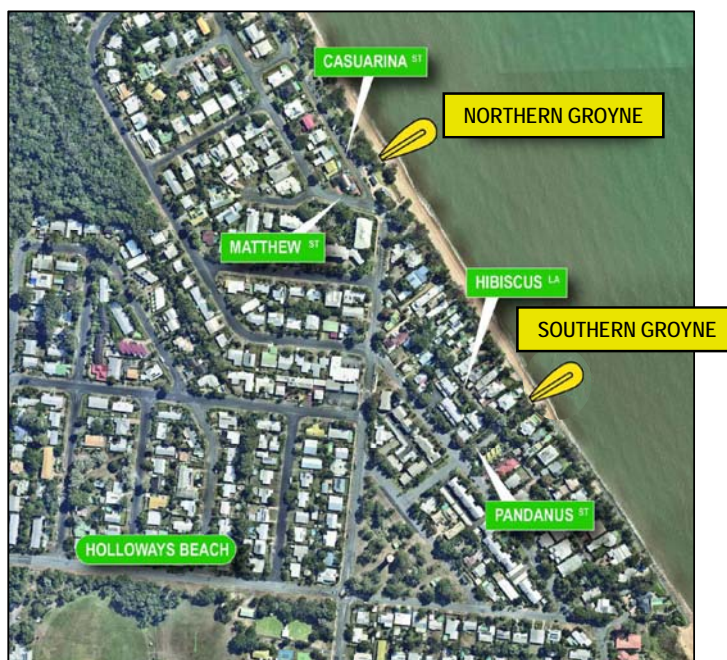
Groyne locations

The new rock groyne at Oleander St will be constructed at the same location as the deteriorated sand-bag groyne. Pedestrians will be able to walk around the groyne via the recently redeveloped esplanade (approx. level 3.5 metre AHD). The new rock groyne for the southern end is proposed to be located in front of the public access walkway to the beach at the end of Pandanus St. At this site, pedestrians will be able to walk around the groyne via the existing beach access point (approx. level 2.5 metre AHD).
