Report on Management of Drowning Risks

# Babinda Boulders

COPY  
Report on Management of Drowning Risks | Babinda Boulders (2022)

ASSESSOR  
Oliver Fearman | Consulting  
email: ofearman@hotmail.com  
phone: +61 458 084 325

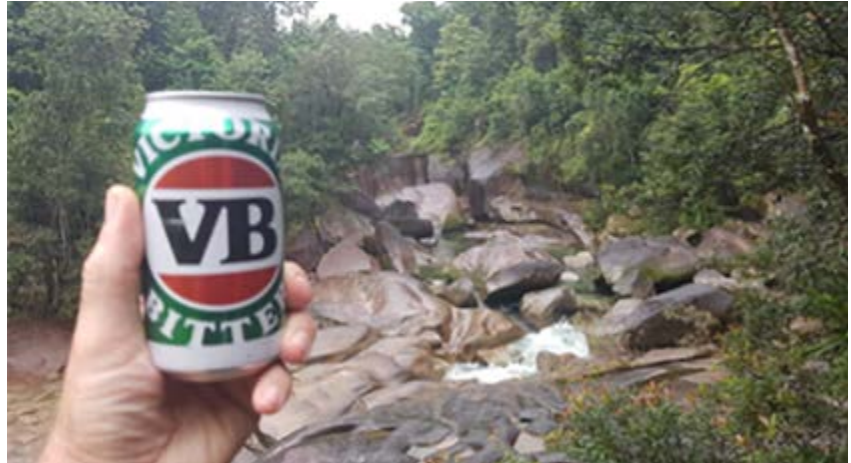
Of the coroner’s reports observed during this project, three indicated alcohol and/or cannabis to be present in the drowned persons systems. This, combined with the known frequency of BBQs and picnics at the location, indicate that alcohol and drugs are a risk factor for Babinda Boulders. Observed online and social media content also suggest these risk factors to be relevant to the site (see image above). The most likely impact being impaired cognitive function, decision-making and risk perception for those under the influence of these substances while at Babinda Boulders.

IMAGE FROM SOCIAL MEDIA TAKEN WITHIN THE NGZ.

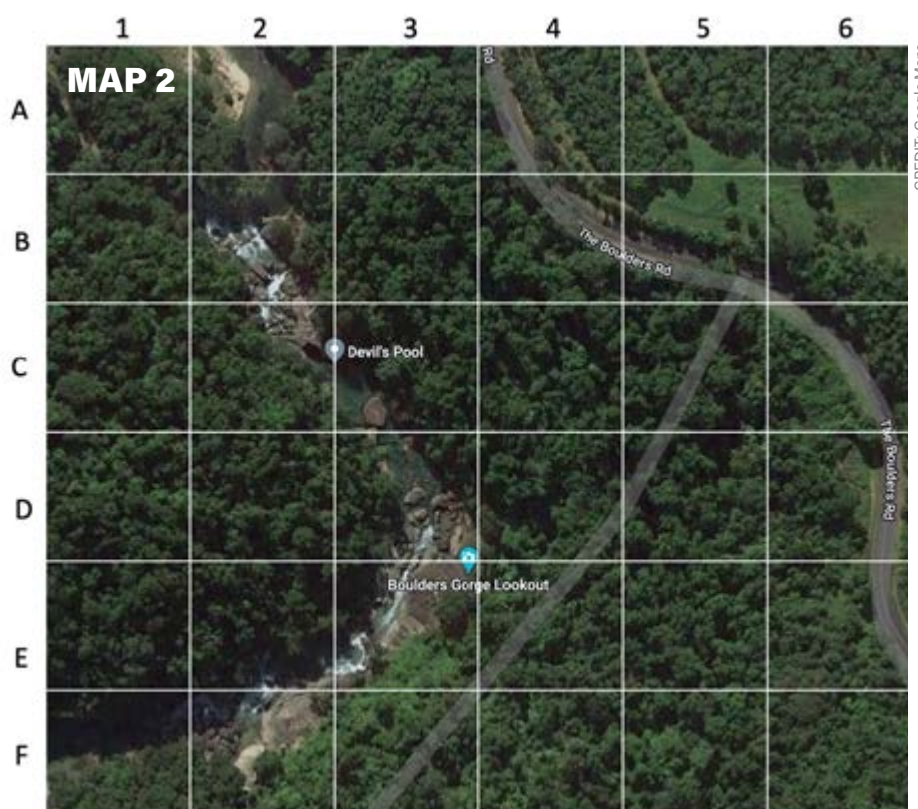
During site visits with stakeholders, it was identified that the “common names” for sections of Babinda Boulders, particularly The Washing Machine and The Chute, are applied to a number of different locations in the NGZ. For these reasons we will use Map 2 (see beside) and reference points from this to discuss the site-specific drowning hazards.

THE NGZ AT BABINDA BOULDER.

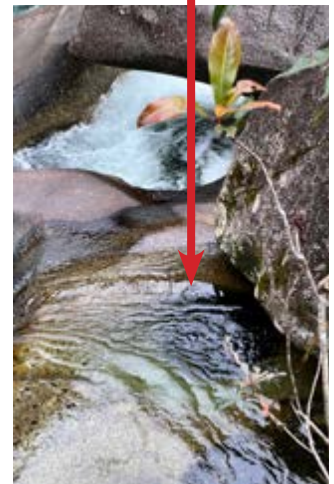
There are several locations on site (B2, C2, C3 and E3 – Map 2) where rock formation, caves and channels allow water to flow through but block larger items from passing through, such as logs and people. Gaps between rocks or caves in rocks force water through a smaller hole, creating the equivalent of a plug – a person can get sucked in, plug the gap and then not move out again because they are pinned by the weight of the water. These hazards are referred to as “sieves” or “siphons”. It was conveyed by numerous stakeholders that the areas above and below Devil’s Pool contain networks of such caves and crevices.

While the forces involved may vary depending on flow rates at the time, Emergency Response personnel conveyed that removing objects from such hazards can be physically impossible for a group of adults with retrieval equipment. A swimmer sucked into such a hazard will not be able to escape.

These hazards do not look dangerous to the untrained eye, and can only be recognised with knowledge of the rock formation. Visitors who were observed entering the NGZ during a site visit were swimming near such hazards, while avoiding the perceived risk of the “big drop off” into Devil’s Pool section of the creek.

EXAMPLE OF A SIEVE HAZARD CAUSED BY A ROCK CAVE LOCATED AT C2 – MAP 2.

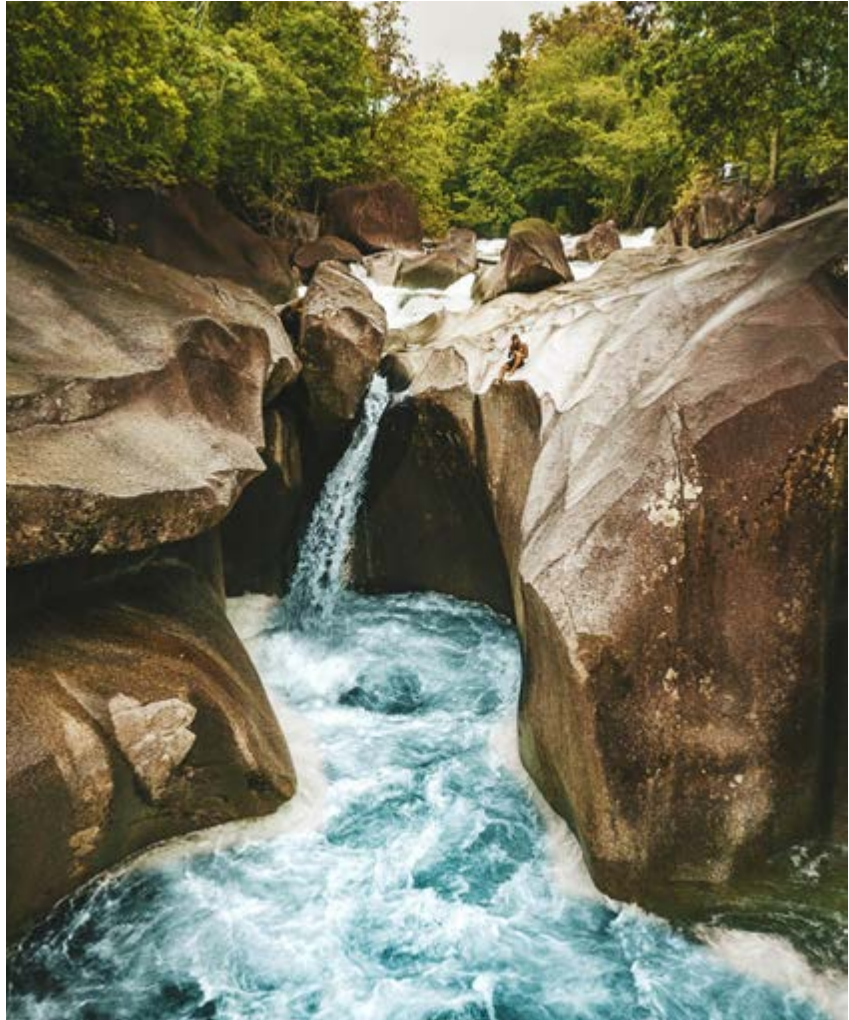
STEEP ROCK LEDGES SURROUNDING DEVIL'S POOL.

The Devil's Pool section of the creek is relatively slow moving and deep compared to sections above and below. However, to enter this pool, you must jump from surrounding rock ledges. The sides of the pool are steep leading to difficulty in exiting the pool and requiring swimmers to swim towards the higher risk sections of the creek in order to get out, increasing their risk of being caught in the previously mentioned water flow hazards.

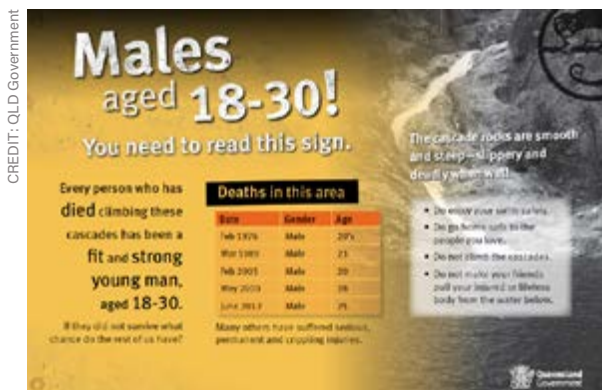
SIGNAGE INSTALLED IN QUEENSLAND NATIONAL PARKS TARGETING THE MOST AT RISK AGE GROUP.

Ensure families and traditional owners are consulted on signage content and placement.

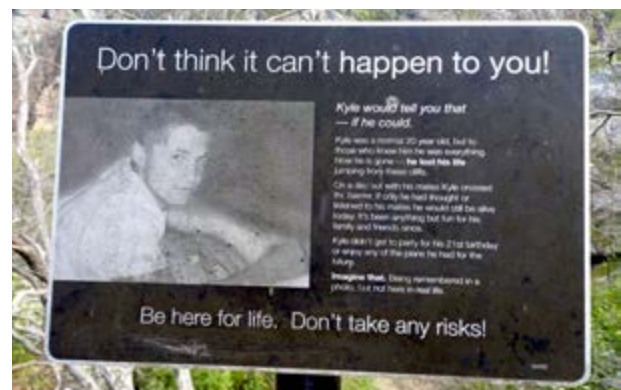
SIGN SHARING A PERSONAL STORY RELEVANT TO THE TARGET AUDIENCE.
